Engineering Failure Analysis 10 (2003) 215–221

## Failure analysis of an elbow tube fitting

Reza A. Mirshams<sup>a,\*</sup>, Mehdy Sabbaghian<sup>b</sup>

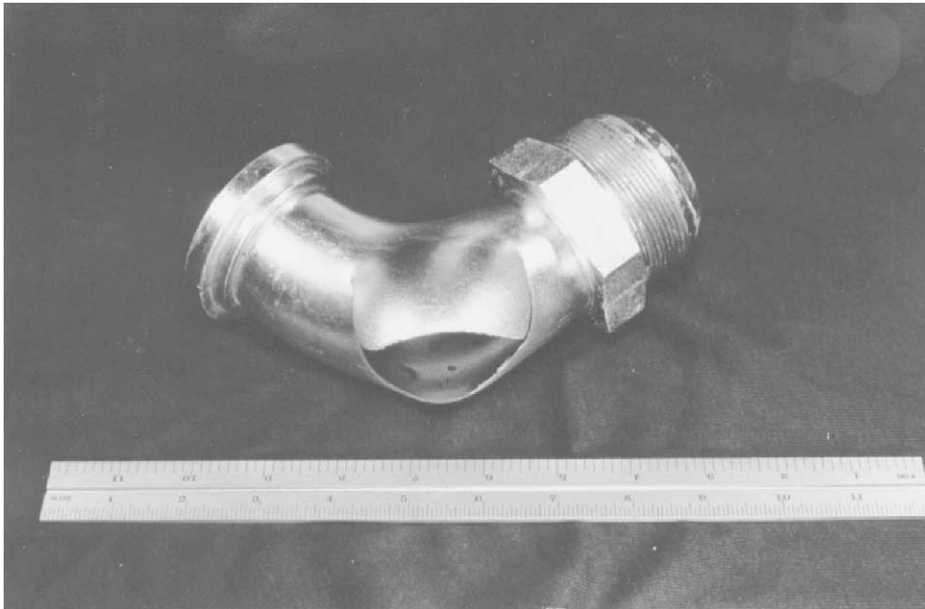
Fig. 2. The failed fitting tube.

Fracture started in the stretched portion of the tube wall. Bulging due to over stretching from internal pressure is evident (Fig. 2). Occurrence of a localized neck in the place of fracture initiation is visible. The crack has extended beyond the bulged area due to the maintenance of the internal pressure.

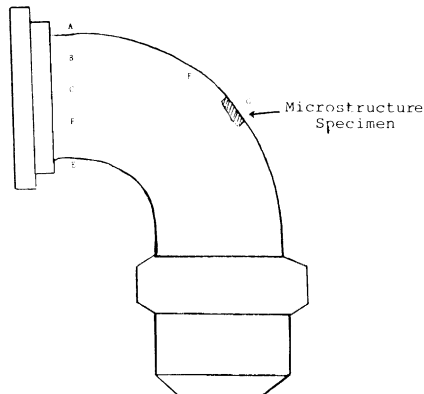
The conventional manufacturing process for tube bending is a cold forming process using special tooling to avoid buckling and folding. The following observations from Table 1 are of interest: (a) the thickness of the new tube is different in the area close to the flange from A to E; (b) there is a 20% thickness reduction on the outside curvature from point A to point G. Point E, is the original tube, unaffected by the cold form bending and point G has the maximum stretch due to cold work. In addition, the process caused about 15% difference in thickness between regions of A and E in the new tube, (c) the thickness reduction close to the fracture line is about 32–34% (comparison of E with F and G).

Fig. 3. Sketch of the new fitting tube. The marked area shows location of specimen for microstructure examination. The letters show locations of thickness measurements.

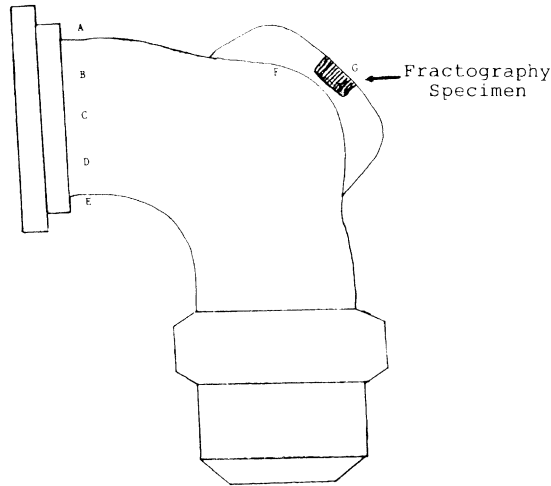
Fig. 4. Sketch of the failed tube. The marked area shows location of specimen for fractography examination. The letters show locations of thickness measurements.

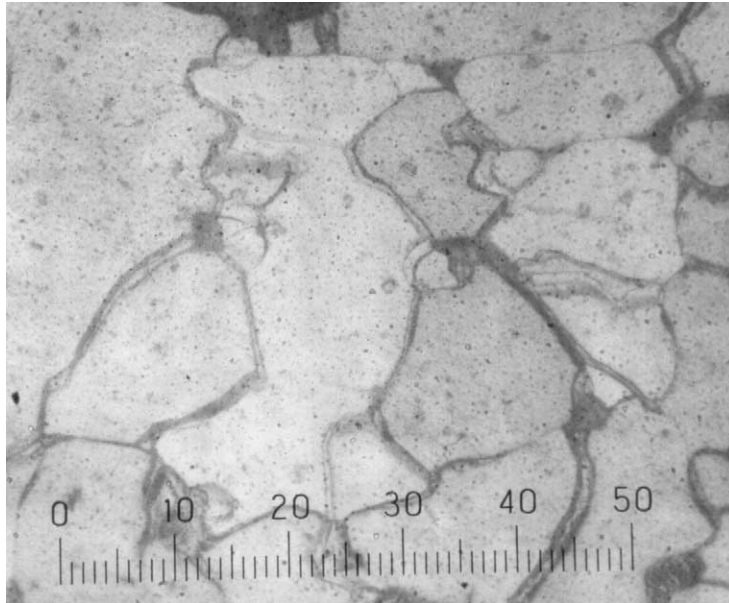
Fig. 5 indicates that the steel was normalized after the bending process. Figs. 5 and 6 show a ferritic microstructure plus a few patches of pearlite. Grains have not elongated in the bending axis. Non uniformity in size and distribution is evident. Examination at higher magnification, Fig. 5, shows a thick precipitation in the grain boundary. No chemical analysis was carried out for the grain boundary compositions. The small amount of pearlite in Fig. 6 indicates that the carbon content should be in the range 0.10–0.12%. The microstructure indicates the material is a low plain carbon steel in the range of C1010 to C1015 [3,4].

Fig. 5. Microstructure of the new tube at the G magnification 600X.

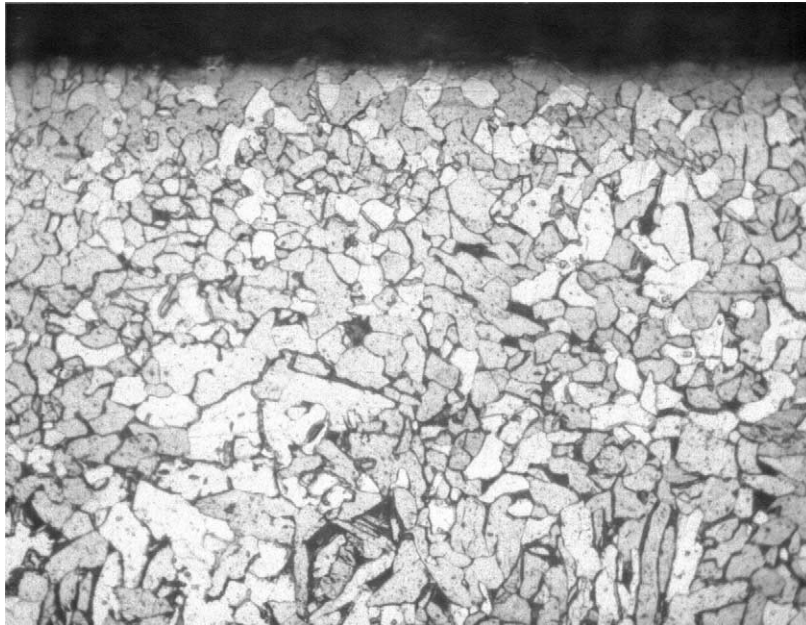
Fig. 6. Microstructure of the new tube at G, magnification 100X.

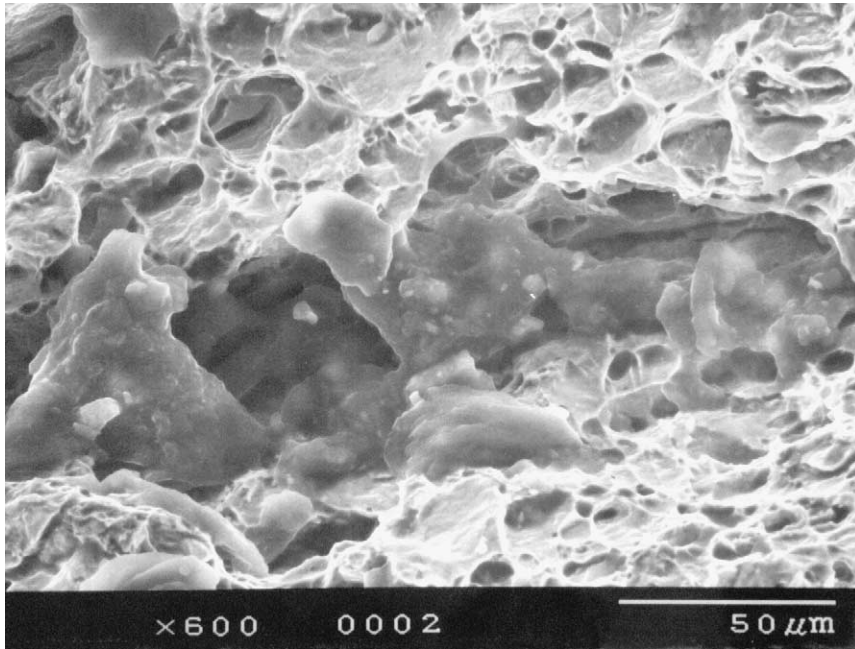
Fractography of the fractured section from the bulged area shows a ductile mode of fracture in which dimples are mostly small and shallow, typical of shear deformation and fracture. Elongated dimples are observed in some regions. This could be attributed to orientation of grains in different regions. The inhomogeneous microstructure is the result of non uniformity of grain sizes and possible precipitation of a ductile phase in grain boundaries. The inhomogeneous microstructure through the wall thickness could

Fig. 7. SEM photomicrograph of the fracture surface shows shear mode fracture.

easily provide deficiencies in the material integrity. This will lead to premature failure initiation [5]. Fig. 7 is a representative fracture surface by SEM.
