Engineering Failure Analysis 10 (2003) 215–221

## Failure analysis of an elbow tube fitting

Reza A. Mirshams<sup>a,\*</sup>, Mehdy Sabbaghian<sup>b</sup>

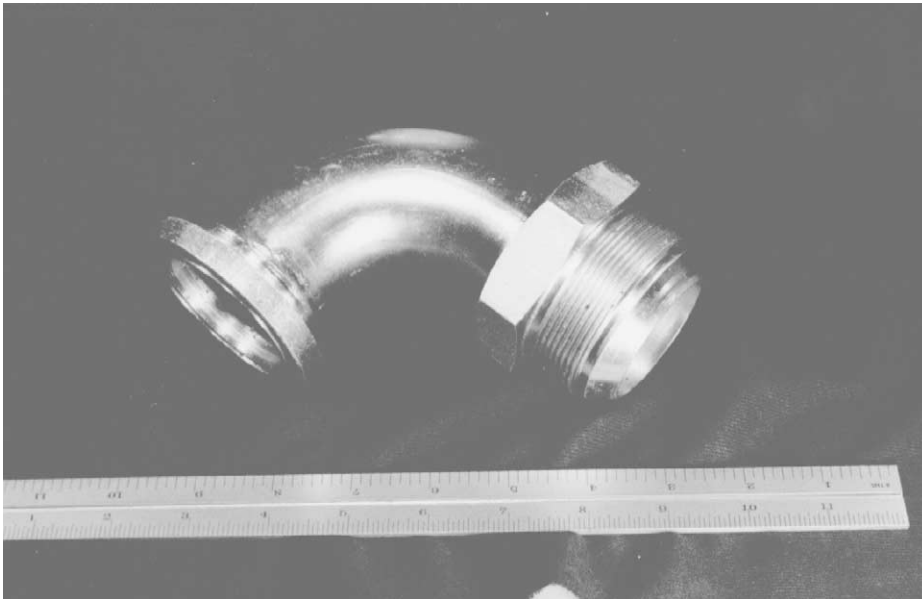
Figs. 1 and 2 illustrate an exemplar new elbow and the subject failed elbow, respectively. The bend angle is close to  $90^\circ$  (right angle). The outer and inner diameter of the tube, away from the bend, are about 50.00 and 44.50 mm, respectively. Both ends of the tube have welded flanges as shown in Figs. 1 and 2. The tube is seamless. The thickness of the tube was measured using a digital vernier caliper. Three measurements were made at each position identified in, Figs. 3 and 4, by letters A, B, C, D, E, F, and G. The measurements on the top of the stretched side of bend were made by cutting small sections for metallography examination. Table 1 summarizes the average measurements at each position on the tube fitting for the new and failed tubes.

Fig. 1. A new fitting tube.
